3. PHASE I FIELDWORK NARRATIVE

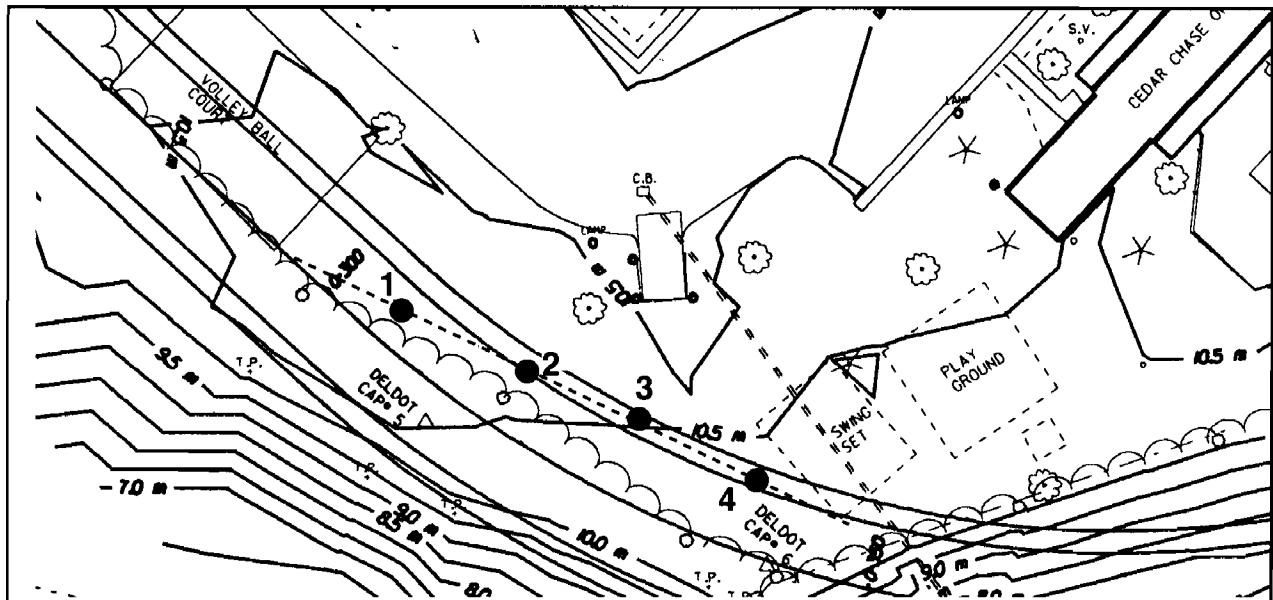
FIGURE 13: The first four tests were sunk along a line between two recreational structures, a volleyball court and a swingset, in the Cedar Chase Apartment complex. Along the line, about 50 meters, a prevailing pattern of disturbance was apparent. A fifth test was attempted near the swing set, at right, but the resisting soil proved to be a packed gravel surface, indicative of the former location of a driveway. The head of White Marsh is at bottom and North is at the top.

The first line of tests was laid off between a swing set and a volleyball court, along which four test pits were sunk. A fifth test was attempted, but the effort was abandoned when it became evident that the landscaped part of the site has been heavily disturbed and rolled rock-hard.

The first test, between 10.5 and 11.5 meters from the corner of the volleyball court, revealed a topsoil buried under a recent fill layer that contains plastic trash. This was interpreted as an old ground surface on which landscapers for the apartment project had added a layer of fill. It was on the state property.

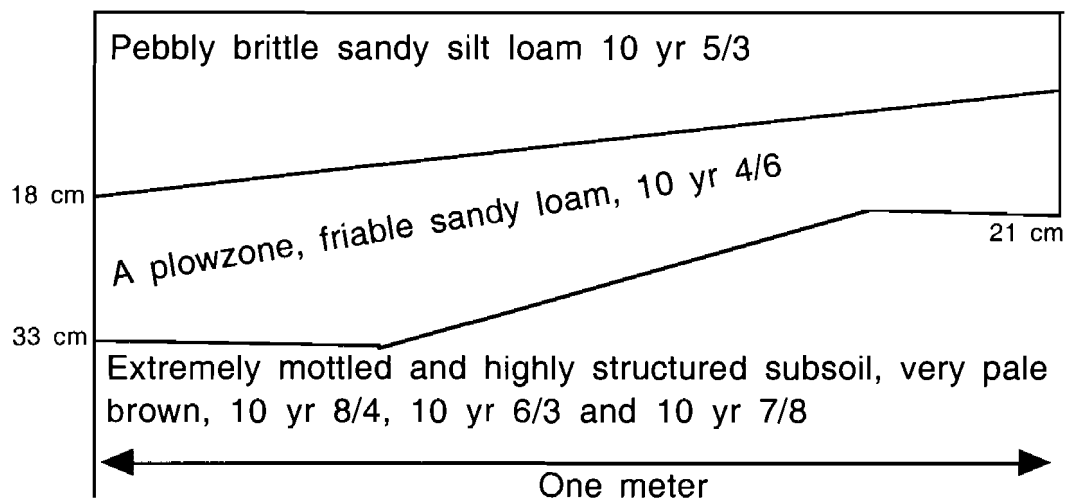
Figure 14: In the second test, 20 meters from the volleyball court, a graded feature was revealed, cutting into the subsoil.

The second test, a half-meter unit at 20 meters from the court, revealed an old feature, that evidently had existed before the apartment complex was built. The silt loam that overlay the old plowzone appeared to have been washed into a depression.

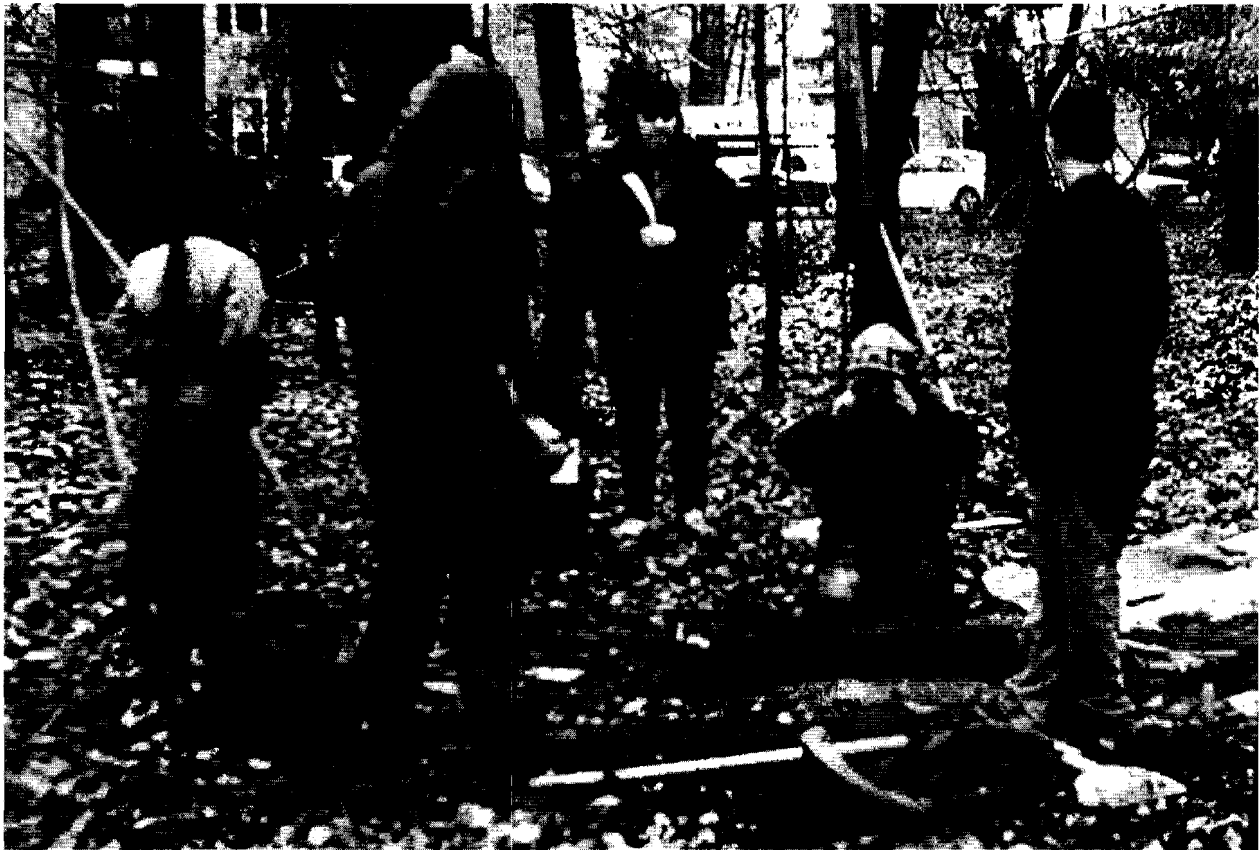
Figure 19: Cara Blume discusses the pottery-rich unit 10 with visitors and workers during the January test campaign

Unit 10, only 11 meters from point E, contained a large amount of pottery. The twelve-centimeter loamy sand top layer overlay a sandy loam. The unit was excavated to 27 centimeters deep. A total of 49 sherds of

sand-tempered ceramic were recovered, mostly from the southwest quadrant, and mostly from between 12 and 22 centimeters.
